The Thornton Beach State Park deep rotational landslide Daly City, California

Martin D. Liebhardt
San Jose State University

**THE THORNTON BEACH STATE PARK
DEEP ROTATIONAL LANDSLIDE
DALY CITY, CALIFORNIA**

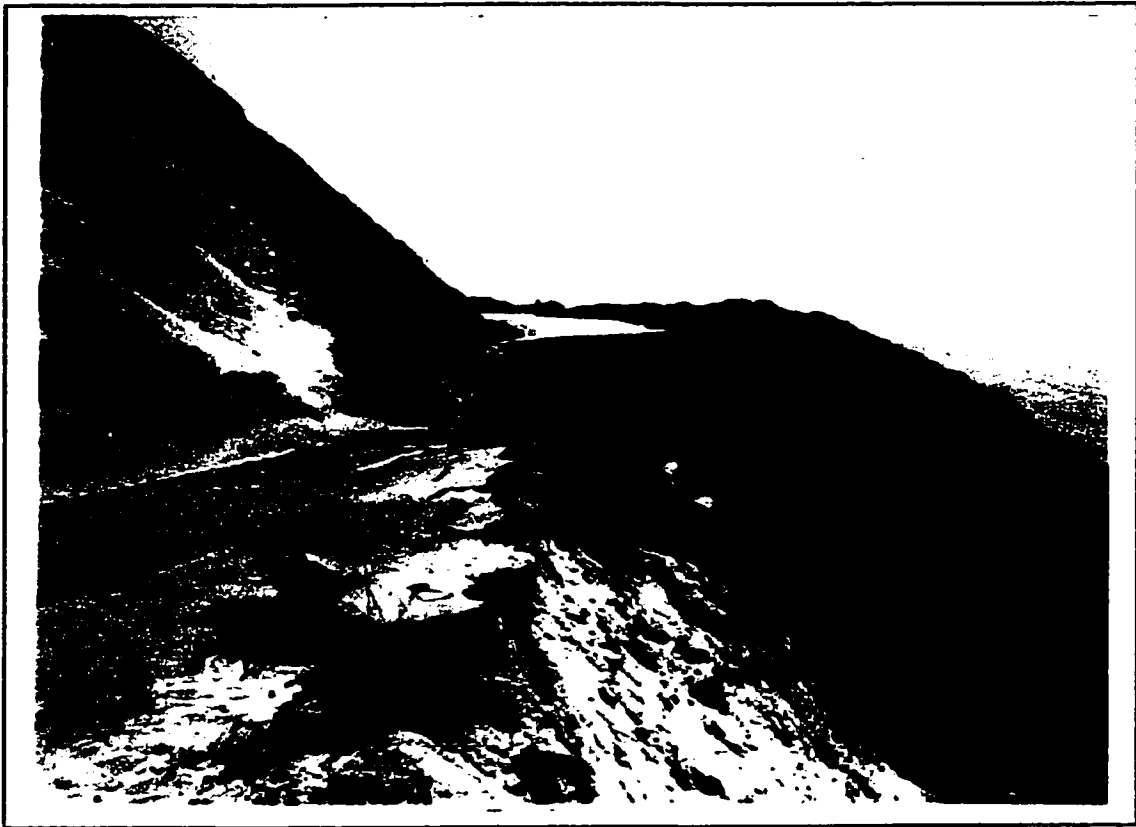
By 1935, the State had regraded and widened the old railroad line for two-lane Route 56 (Highway 1). The highway ran along the coast from San Francisco to Santa Cruz. Like the railroad line, the highway was very difficult to maintain because of landsliding. In 1953, the highway was re-routed away from the landslide-prone coast to more stable ground inland. Severe damage from the March 22, 1957 earthquake and major storms eventually closed Highway 1 in this area in 1958 (Sullivan, 1975 and Bonilla, 1960) (Figs. 12 and 13).

Figure 13. Landslide destruction of Highway 1 at Thornton Beach in 1963 (Sullivan, 1975).

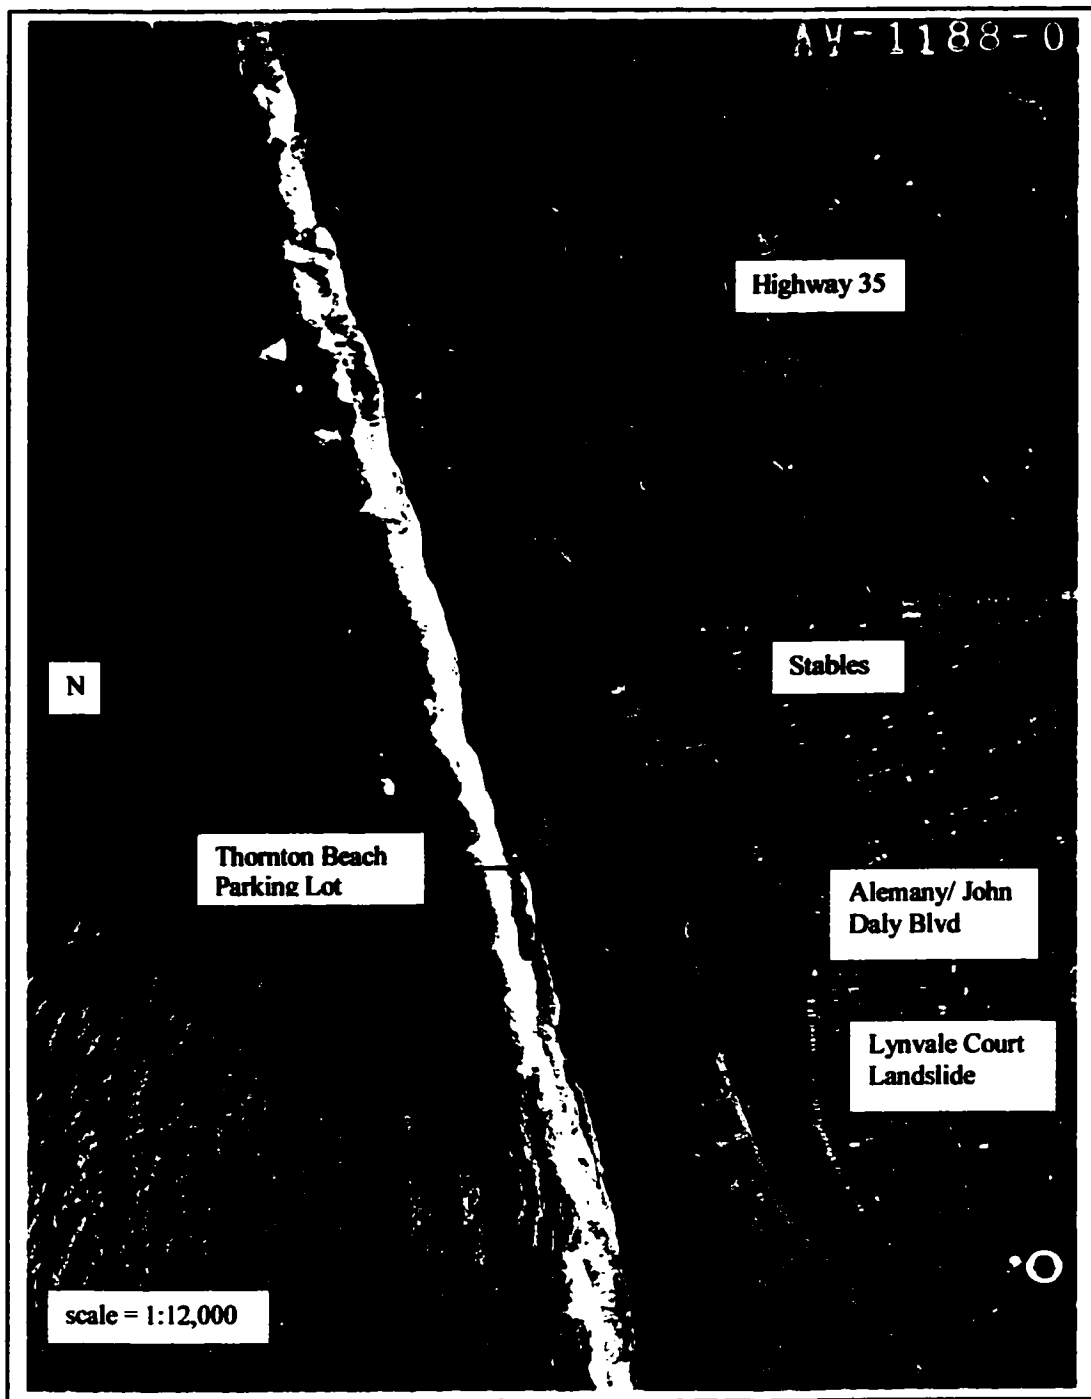
- **The Lynvale Court Landslide (shown in Fig. 15) failed and the six houses in the area are no longer present. The cul-de-sac asphalt is cracked and the failure extends from the street to the beach, approximately 60 meters in length.**
- **Alemany/John Daly Boulevard and the Thornton Beach parking lot, just to the north of the slide, both appear to be intact, but the parking lot has sediment along the edges from debris flows.**
- **As in the earlier pictures, the beaches display steep cliff faces (approximately 30° – 35°) with little vegetation due to the continuous wave action eroding the landslide toe.**

Figure 15. 1975 aerial photograph of Thornton Beach area.

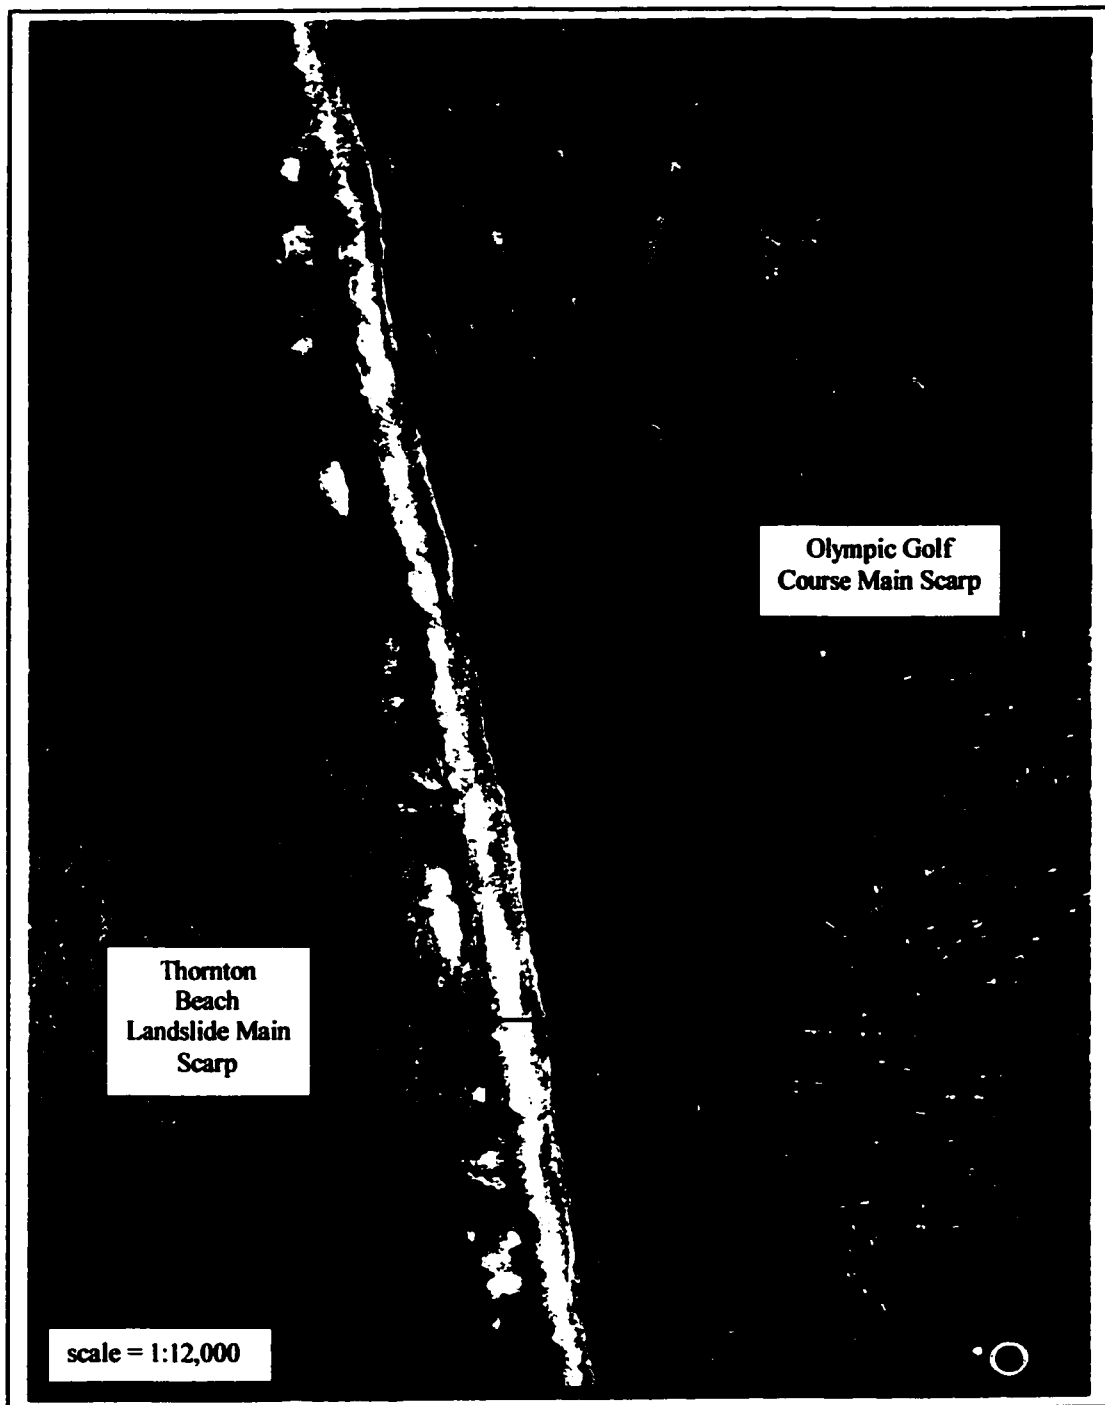
- **Much of Alemany/John Daly Boulevard is disrupted with debris flows and failures along its slopes (shown in Figure 17).**
- **The Lynvale Court Landslide is covered with vegetation except at the bottom of the slide near the beach.**
- **The Thornton Beach Landslide has shallow debris flows along the slope, and the basin below is overgrown with vegetation.**

Figure 17. 1997 aerial photograph of Thornton Beach area.
